This report presents the results of the mine subsidence investigation carried out to assess the current conditions in the two mine levels encountered under the site. Results of the mine subsidence modelling will be provided in a separate report.

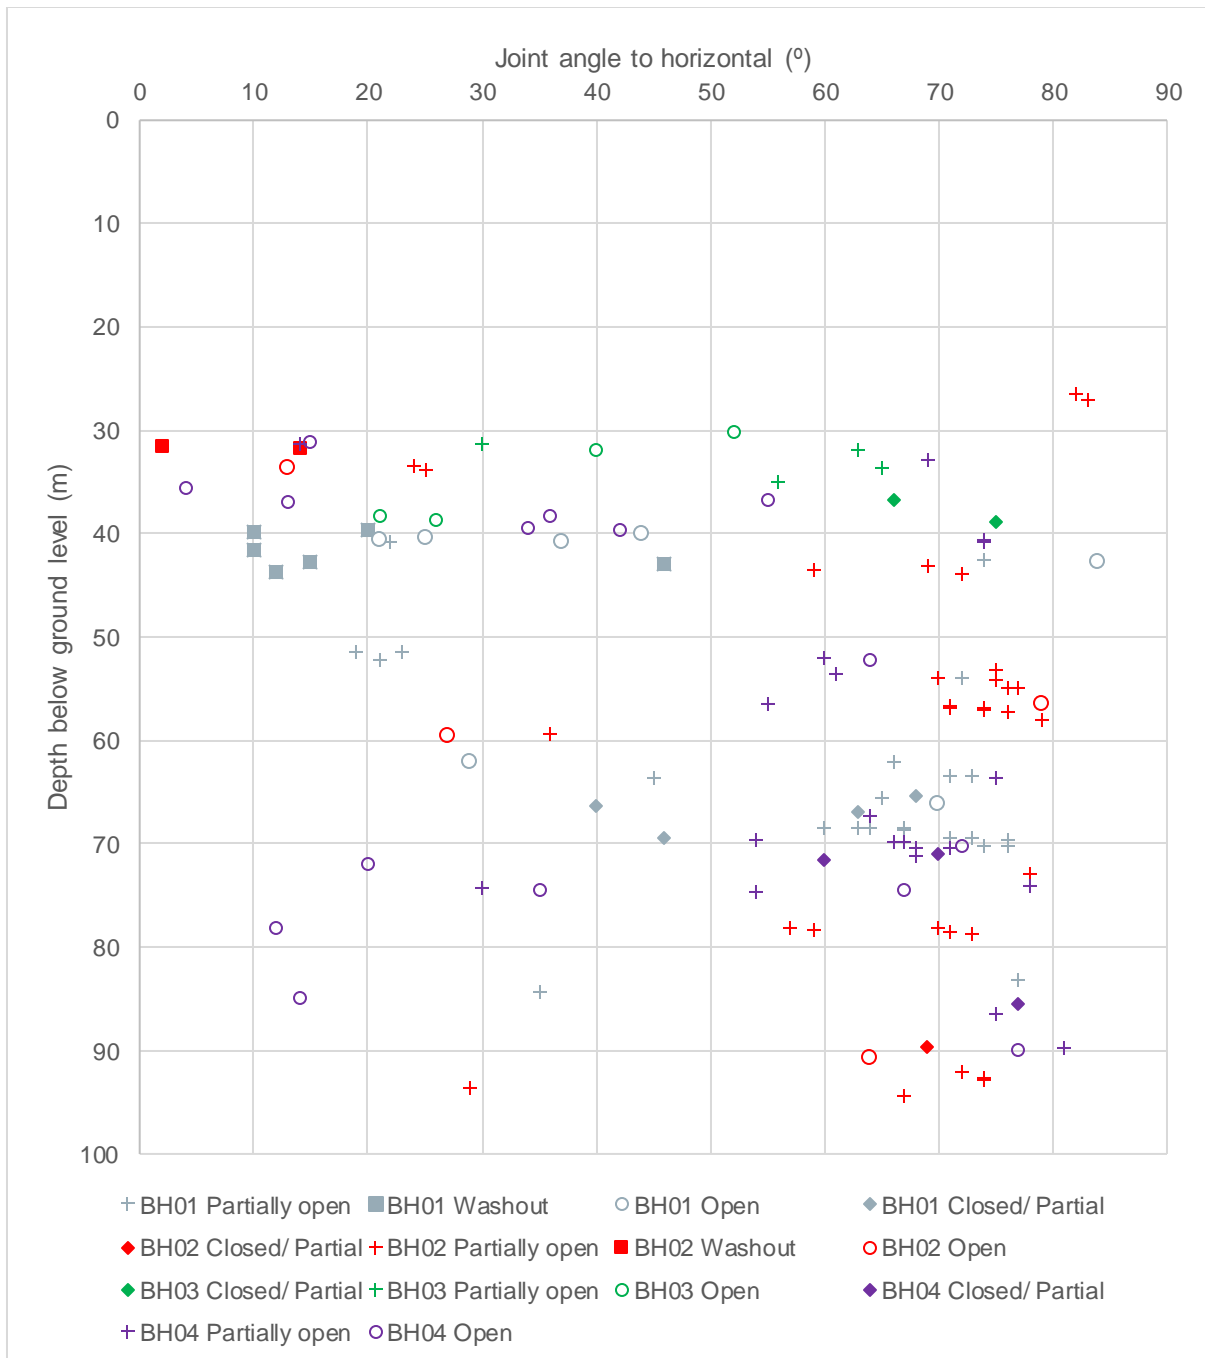
Figure 2: Summary of defects from televiewer

A summary of the joints and washout defects observed in the televiewer is provided in Figure 2.

Based on the above there is an increased density of defects above the Yard Seam which corresponds to the delamination and roof cave in this area.

Within the lower portion, the defects are mostly closed with an increased density of open joints in BH04.

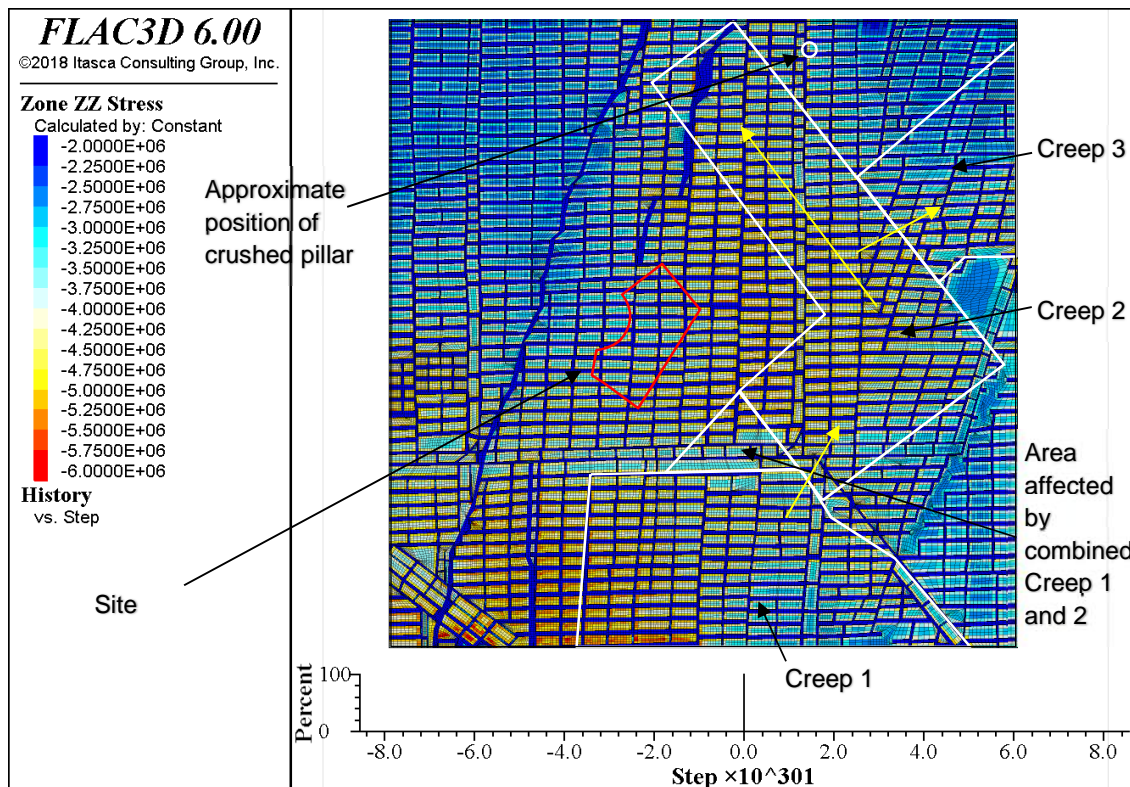
Figure 5: Vertical stress at Borehole Seam level before collapse with historical 'Creeps' shown

An output that summarises the final vertical stress after excavation (at completion of initial mining) is given below in Figure 5. This provides an image of the layout of workings, showing overburden stress being distributed between pillars' cores and the extent of mining.

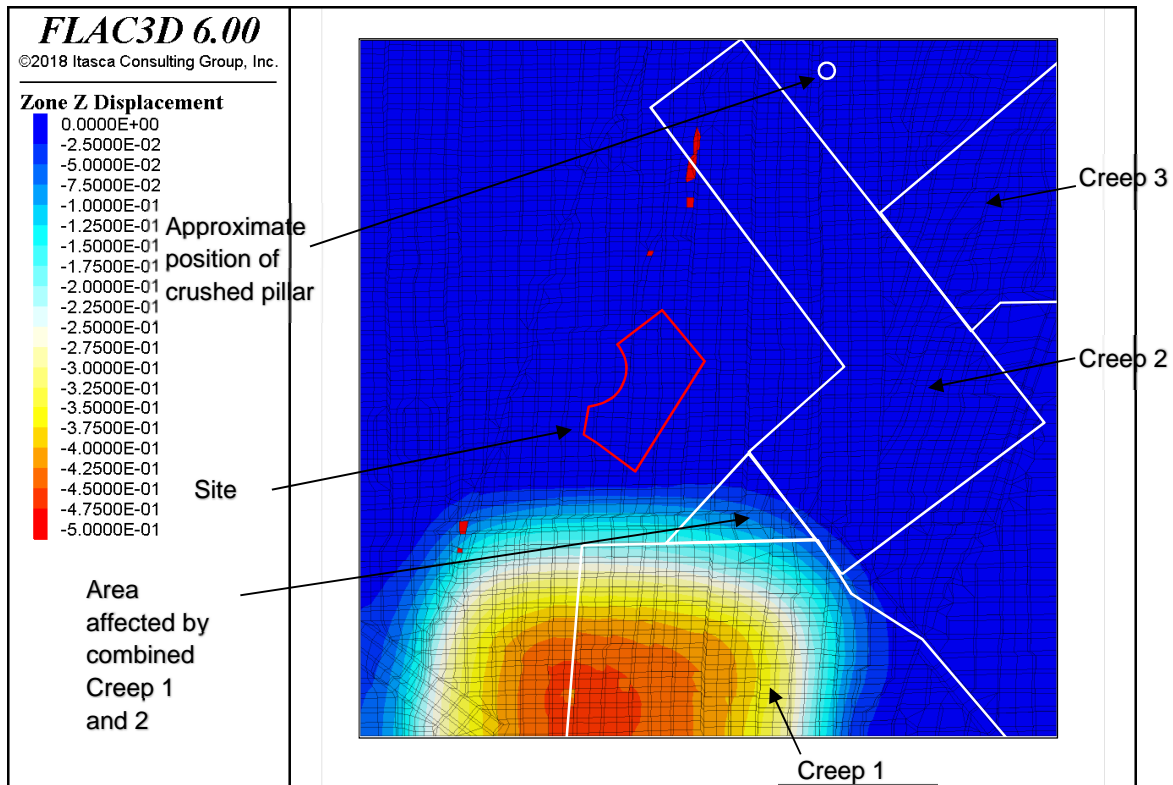
Figure 55: Modelled creep event conceptual surface displacement.

After the addition of grout, the pillar run was retriggered similar to as described above at the edge of historical Creep 1 in the most highly stressed pillars in the model. This settlement is shown in Figure 55. It is noted that with the addition of remedial grouting, the modelled creep and settlement did not extend to The Site as previously illustrated in figures 44 to 51.

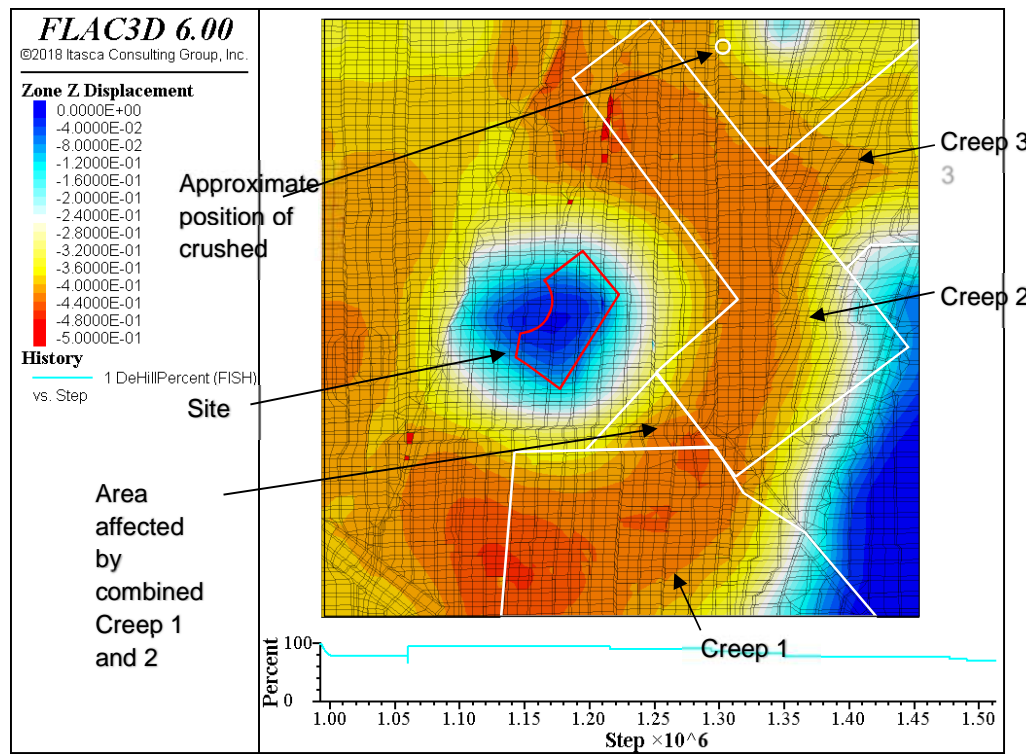
Figure 64: Conceptual vertical displacement with pillar coal at 70% strength with proposed grout (i.e. just before crushing of grouted pillars)

Beyond this reduction, the pillars under the site may be anticipated to start to crush as well. However, instead of the wave of the crush front passing through the site, the effect will be a more controlled collapse.

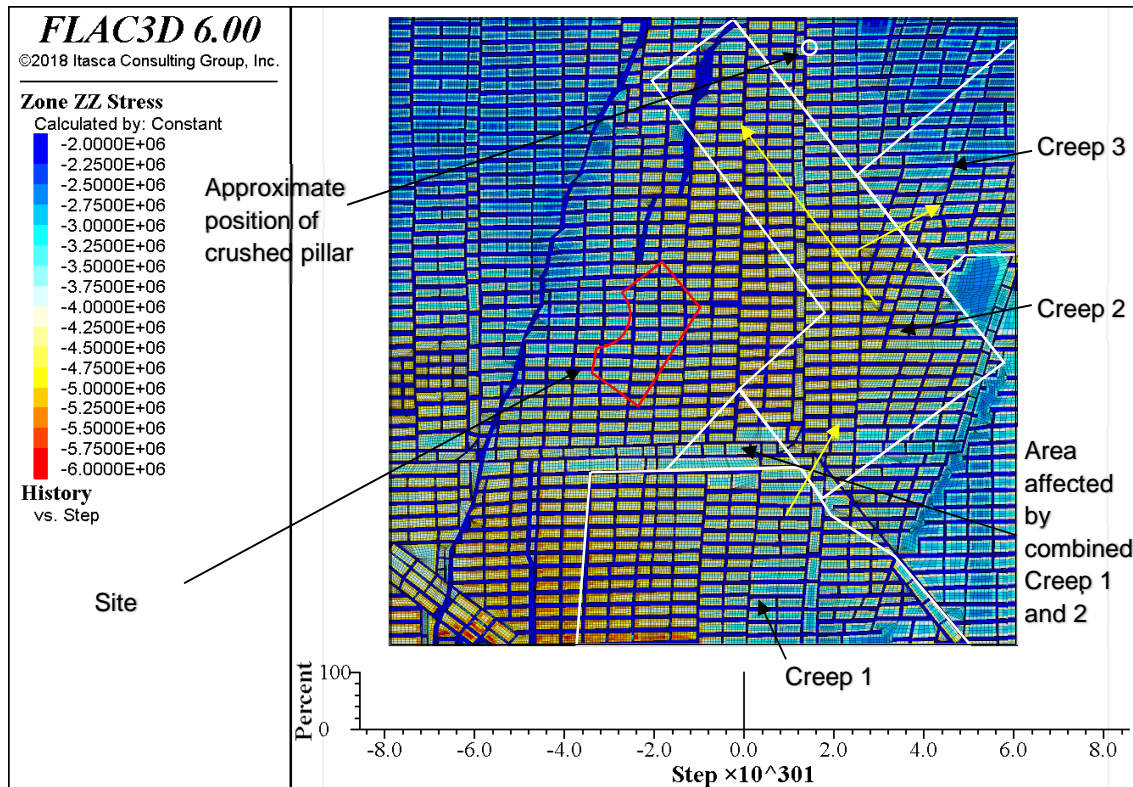
Figure 5: Vertical stress at Borehole Seam level before collapse with historical 'Creeps' shown

An output that summarises the final vertical stress after excavation (at completion of initial mining) is given below in Figure 5. This provides an image of the layout of workings, showing overburden stress being distributed between pillars' cores and the extent of mining.

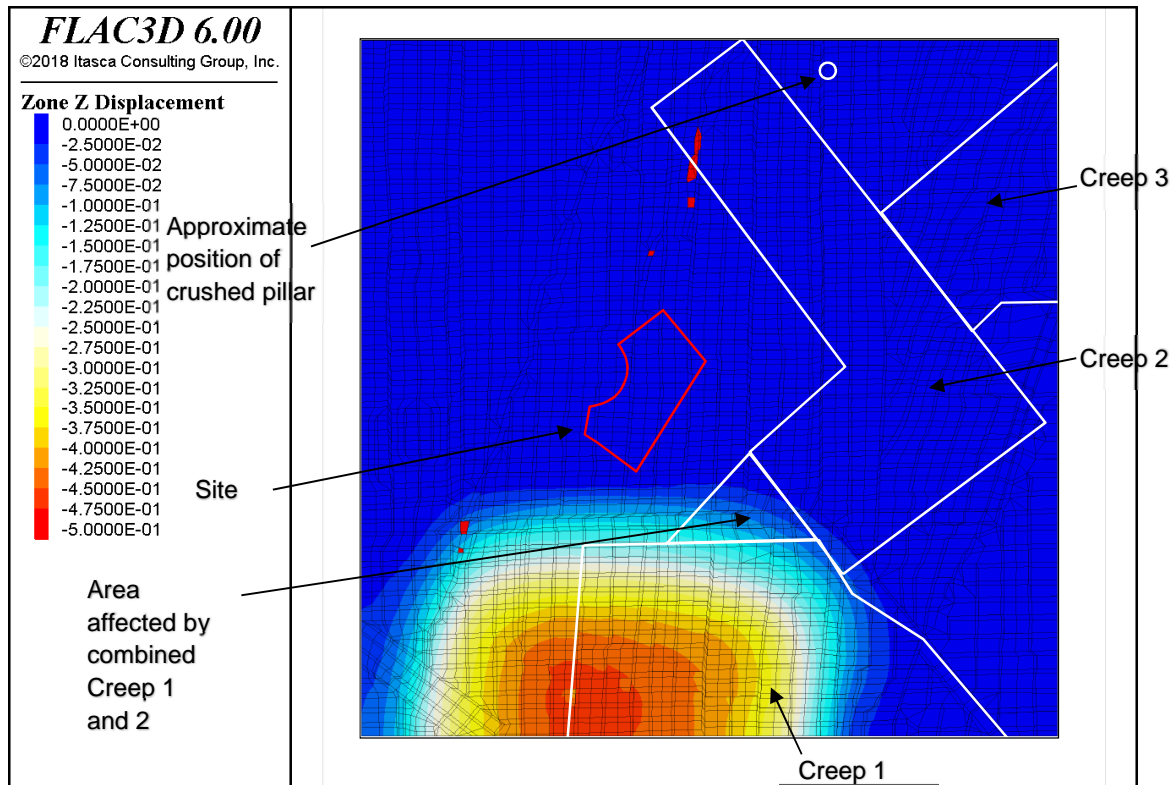
Figure 57: Modelled creep event conceptual surface displacement layout one.

After the addition of the layout one grout, the pillar run was retriggered similar to as described above at the edge of historical Creep 1 in the most highly stressed pillars in the model. This settlement is shown in Figure 57. It is noted that with the addition of remedial grouting, the modelled creep and settlement did not extend to The Site as previously illustrated in figures 44 to 51.

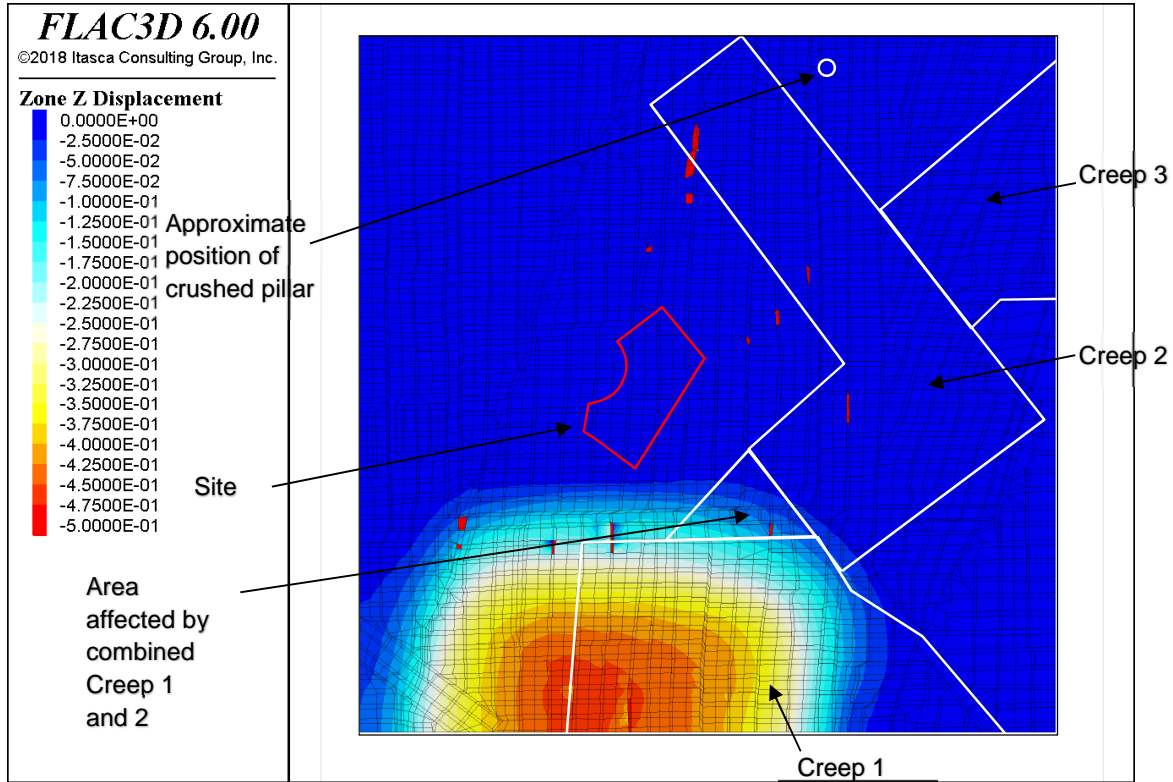
Figure 68: Modelled creep event conceptual surface displacement layout two.

Similar to layout one, after the addition of the layout two grout, the pillar run was retriggered similar to as described above at the edge of historical Creep 1 in the most highly stressed pillars in the model. This settlement is shown in Figure 68. It is noted that this produced similar results to layout one.

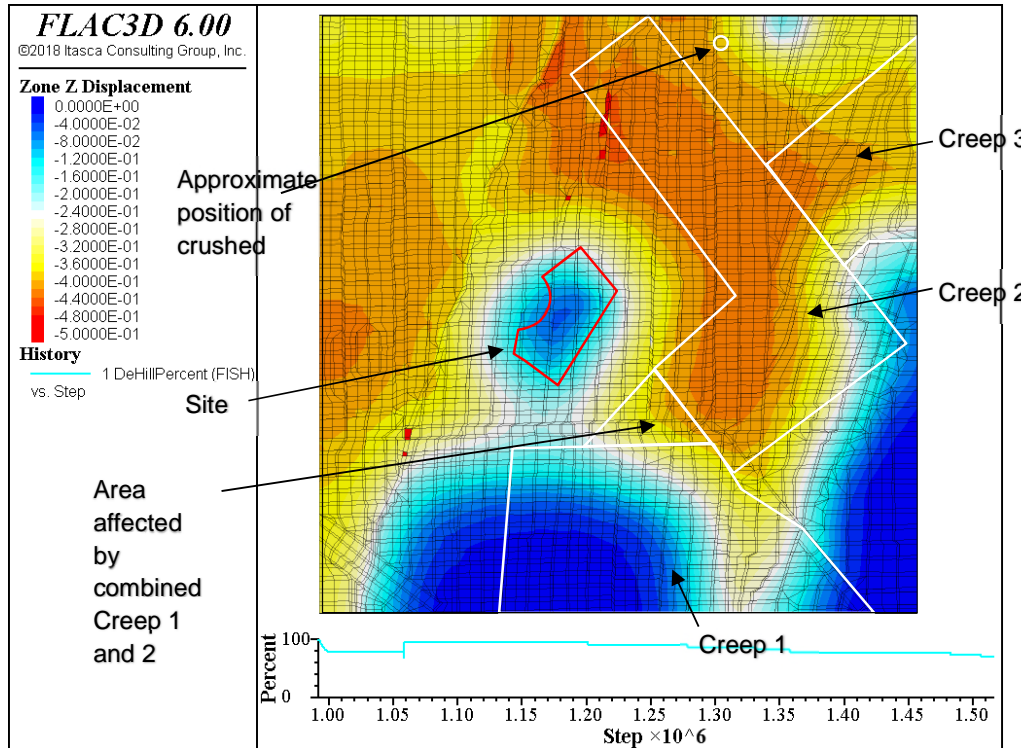
Figure 77: Conceptual vertical displacement with pillar coal at 70% strength with proposed grout (i.e. just before crushing of grouted pillars) layout two.

Beyond this reduction, the pillars under the site may be anticipated to start to crush as well. However, instead of the wave of the crush front passing through the site, the effect will be a more controlled collapse.
