This report presents the results of the mine subsidence investigation carried out to assess the current conditions in the two mine levels encountered under the site. Results of the mine subsidence modelling will be provided in a separate report.

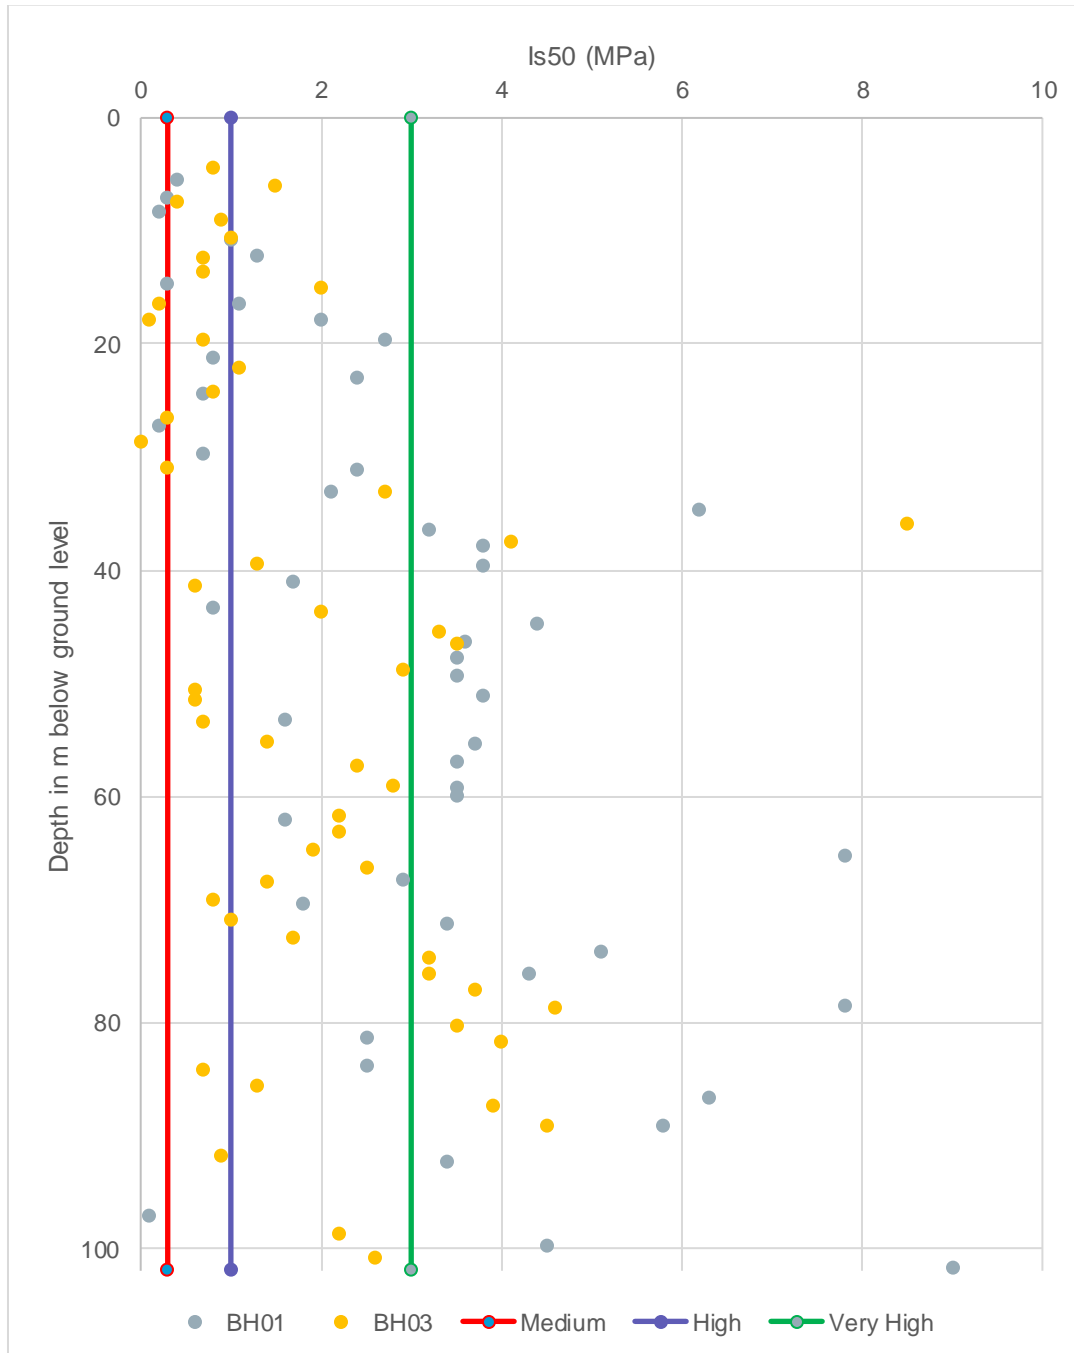
Figure 1: Summary of point load testing

From the testing the rock strength above the Yard Seam is generally low to medium strength, while below the Two Foot Seam the rock strength is generally high to very high.

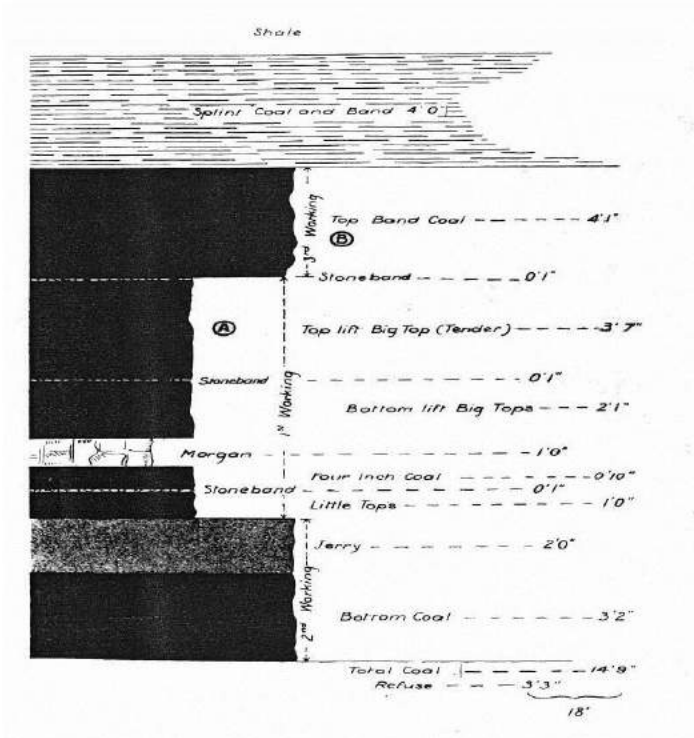
Figure 3: Borehole Seam section from 1908 Royal Commission

"The top lift (A) on the sketch is of an exceptionally tender nature and has little cohesive strength. The coal immediately above (B) is also of a very friable character. Following upon the third operation (dropping the top coal) the splint coal above, and frequently the shale roof, falls in the bords, and together with the dirt bands fill up more or less the space from which the coal has been excavated often to within about 3 feet of the top of the seam, thus, to some extent automatically supporting the pillars. The roof over the seam proper consists of splint coal and bands 4 feet, and overlying shale and sandstone."

The above section is considered to be representative of the Borehole Seam in the area.

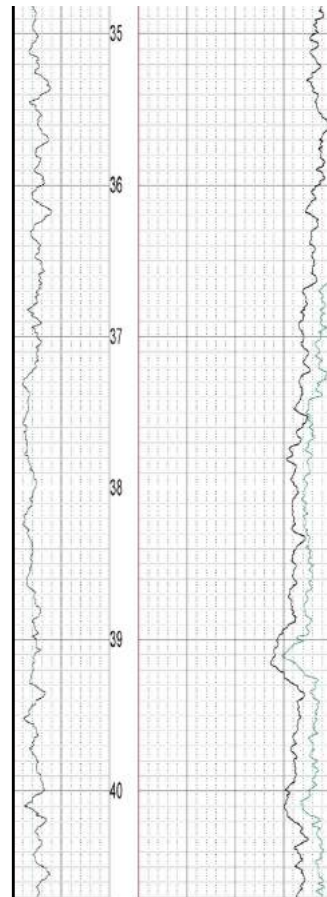
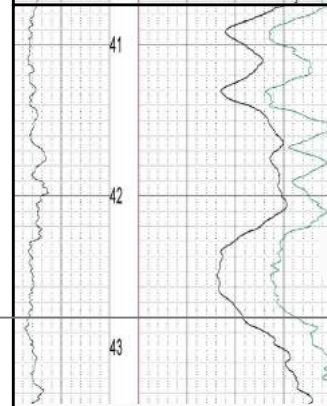
754-NTLGE220504 BH01  
BORD

SMALL  
VOIDS IN  
ROOF

VOID

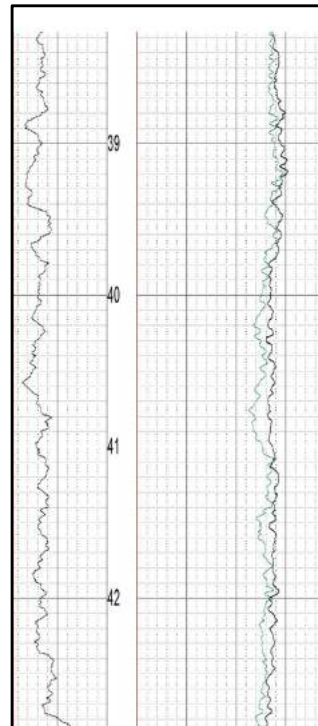
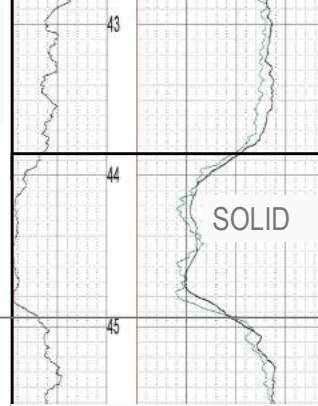
754-NTLGE220504 BH02A  
PILLAR

SOLID

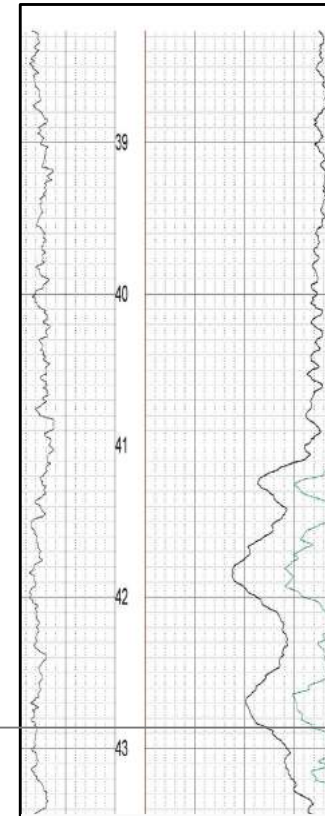
754-NTLGE220504 BH03  
SMALL VOIDS

SMALL  
VOIDS IN  
ROOF

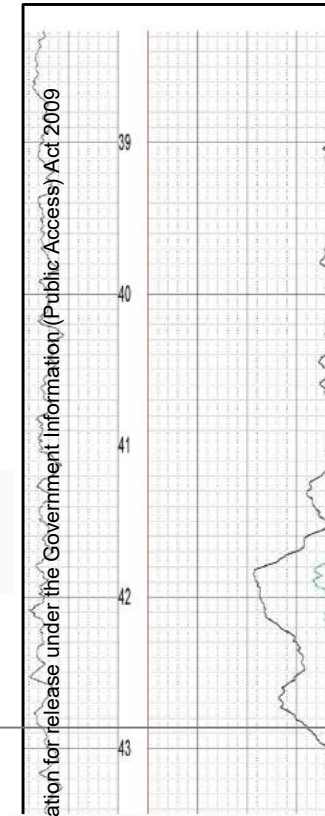
754-NTLGE220504 BH04  
BORD

SMALL  
VOIDS IN  
ROOF

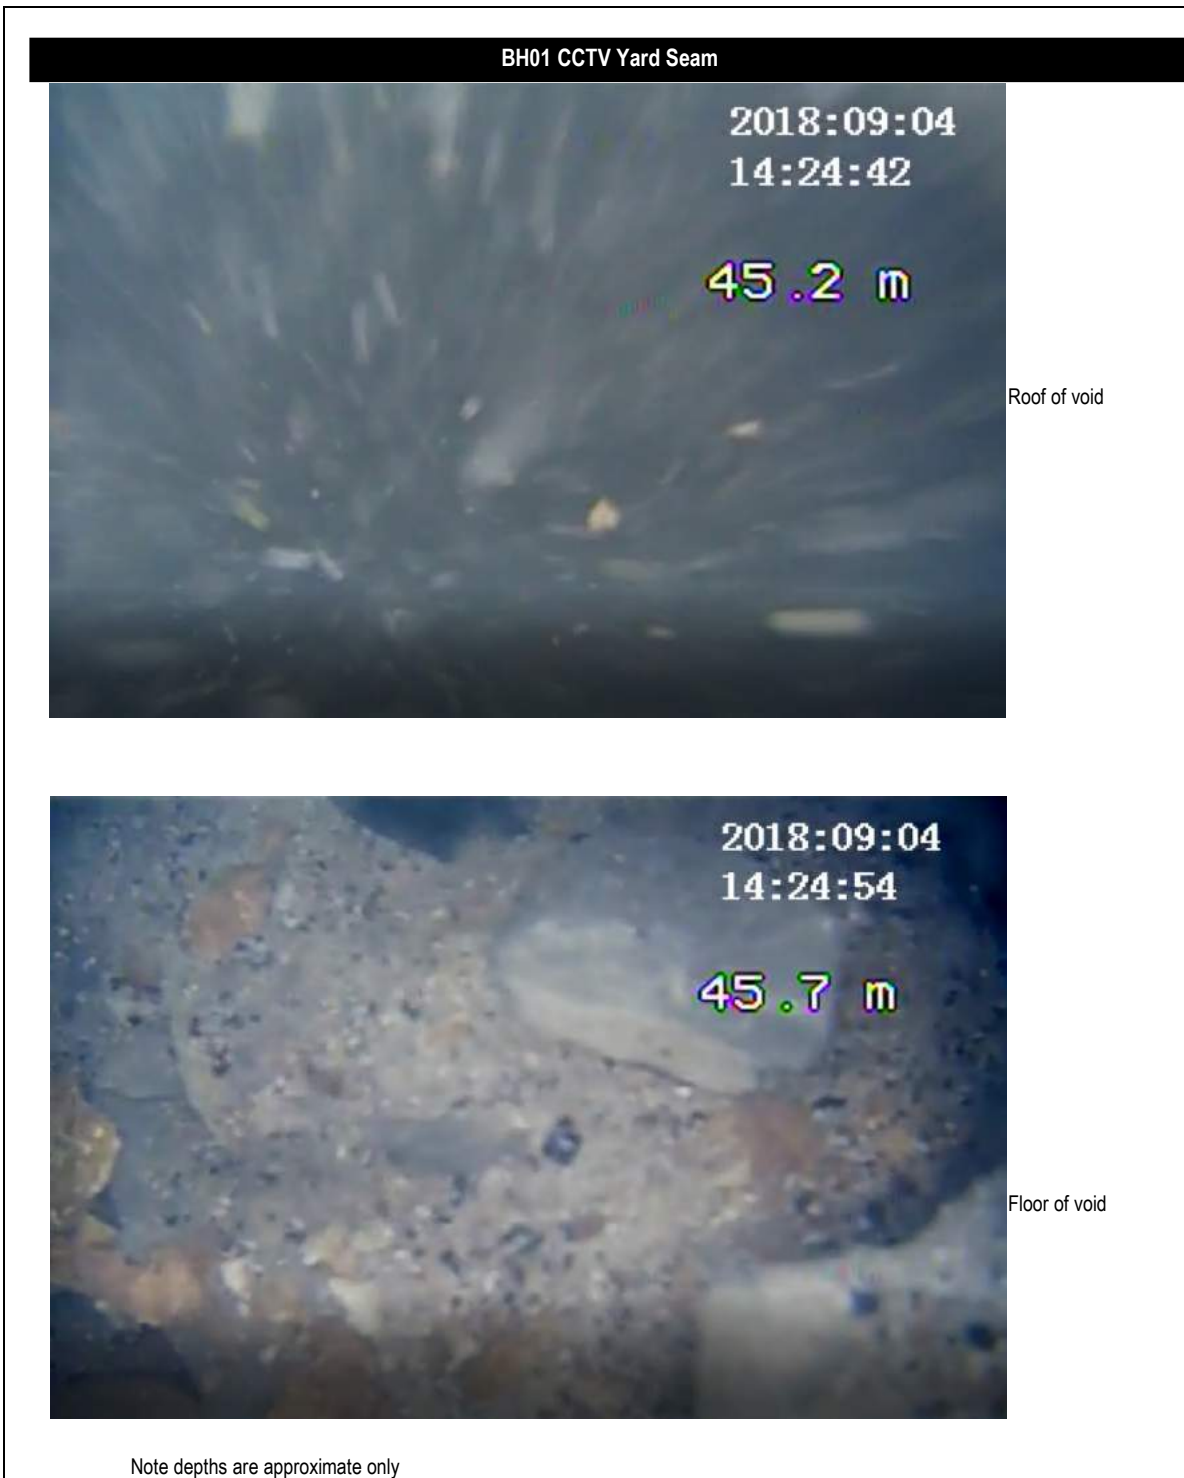
Note depths are approximate only

client:	<b>CRESCENT NEWCASTLE PTY LTD</b>		
approved	<b>JD</b>		project:	<b>PROPOSED RESIDENTIAL DEVELOPMENT</b>		
date	<b>2/11/2018</b>			<b>11-17 MOSBRI CRESCENT THE HILL</b>		
scale	<b>N/A</b>			title:	<b>CCTV SNAPSHOTS BH01 YARD SEAM</b>	
original size	<b>A4</b>			project no:	<b>754-NTLGE220504</b>	figure no: <b>C-BH01 -01</b>

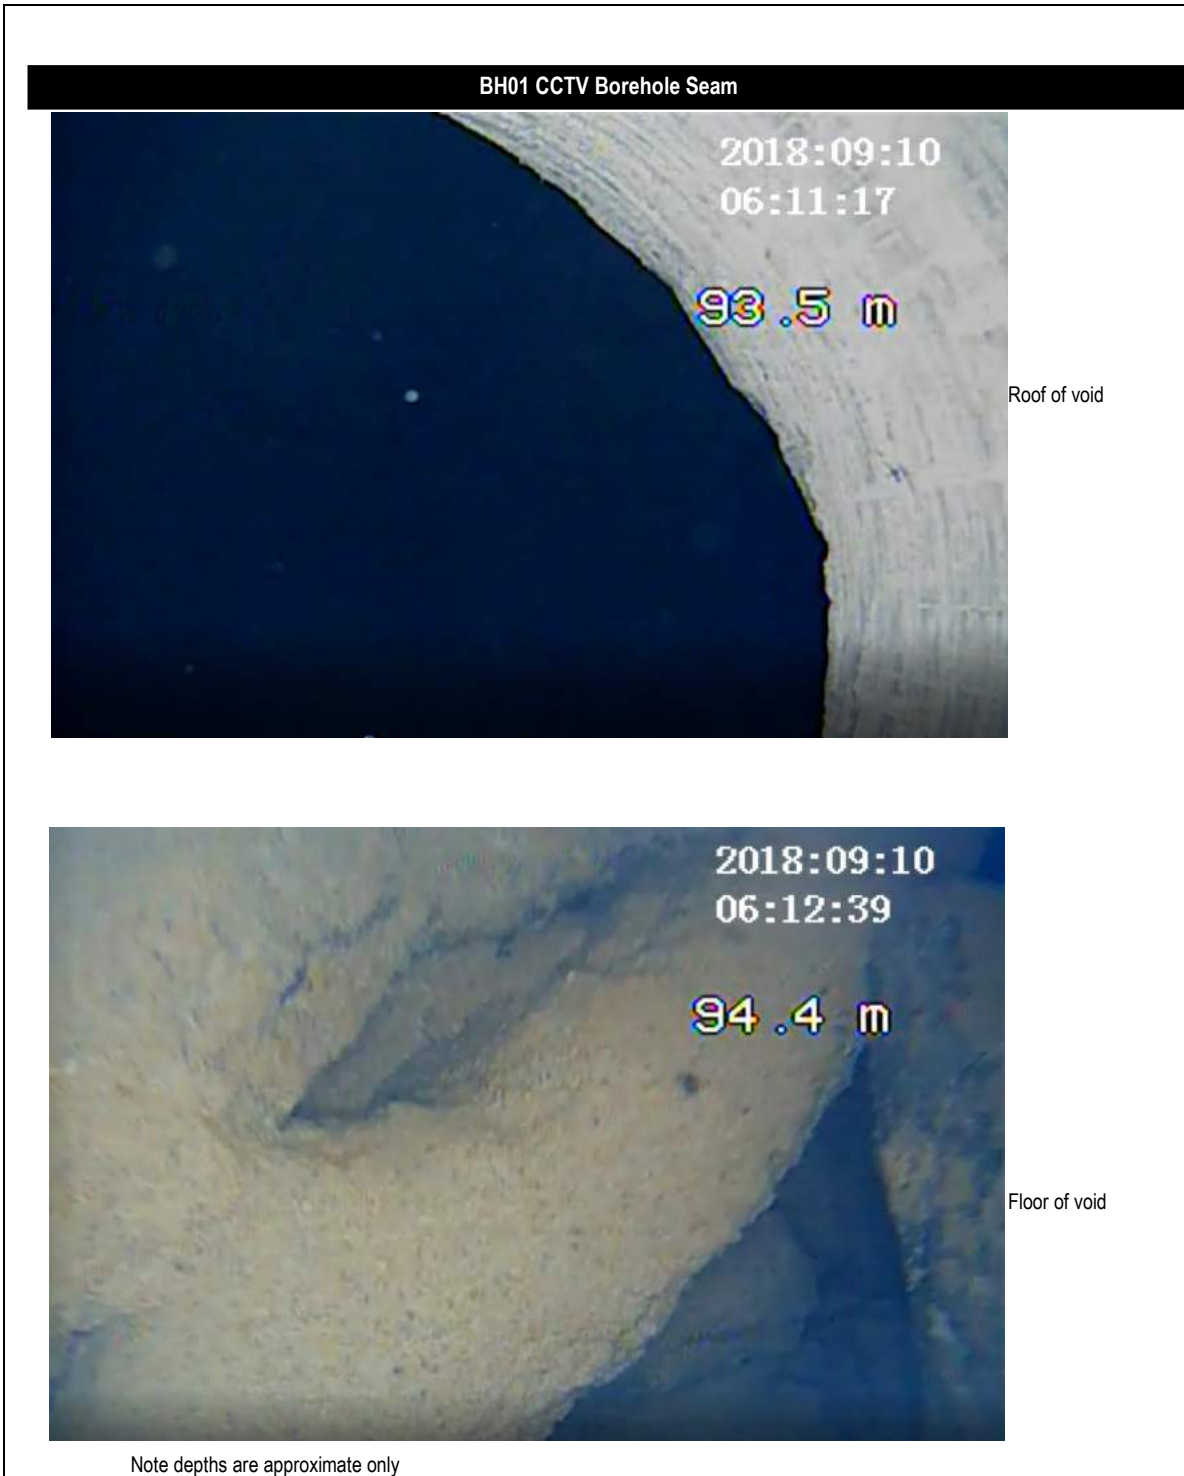
Note depths are approximate only

client:	<b>CRESCENT NEWCASTLE PTY LTD</b>	
approved	<b>JD</b>		project:	<b>PROPOSED RESIDENTIAL DEVELOPMENT</b>	
date	<b>2/11/2018</b>			<b>11-17 MOSBRI CRESCENT THE HILL</b>	
scale	<b>N/A</b>		title:	<b>CCTV SNAPSHOTS BH01 BOREHOLE SEAM</b>	
original size	<b>A4</b>		project no:	<b>754-NTLGE220504</b>	figure no:

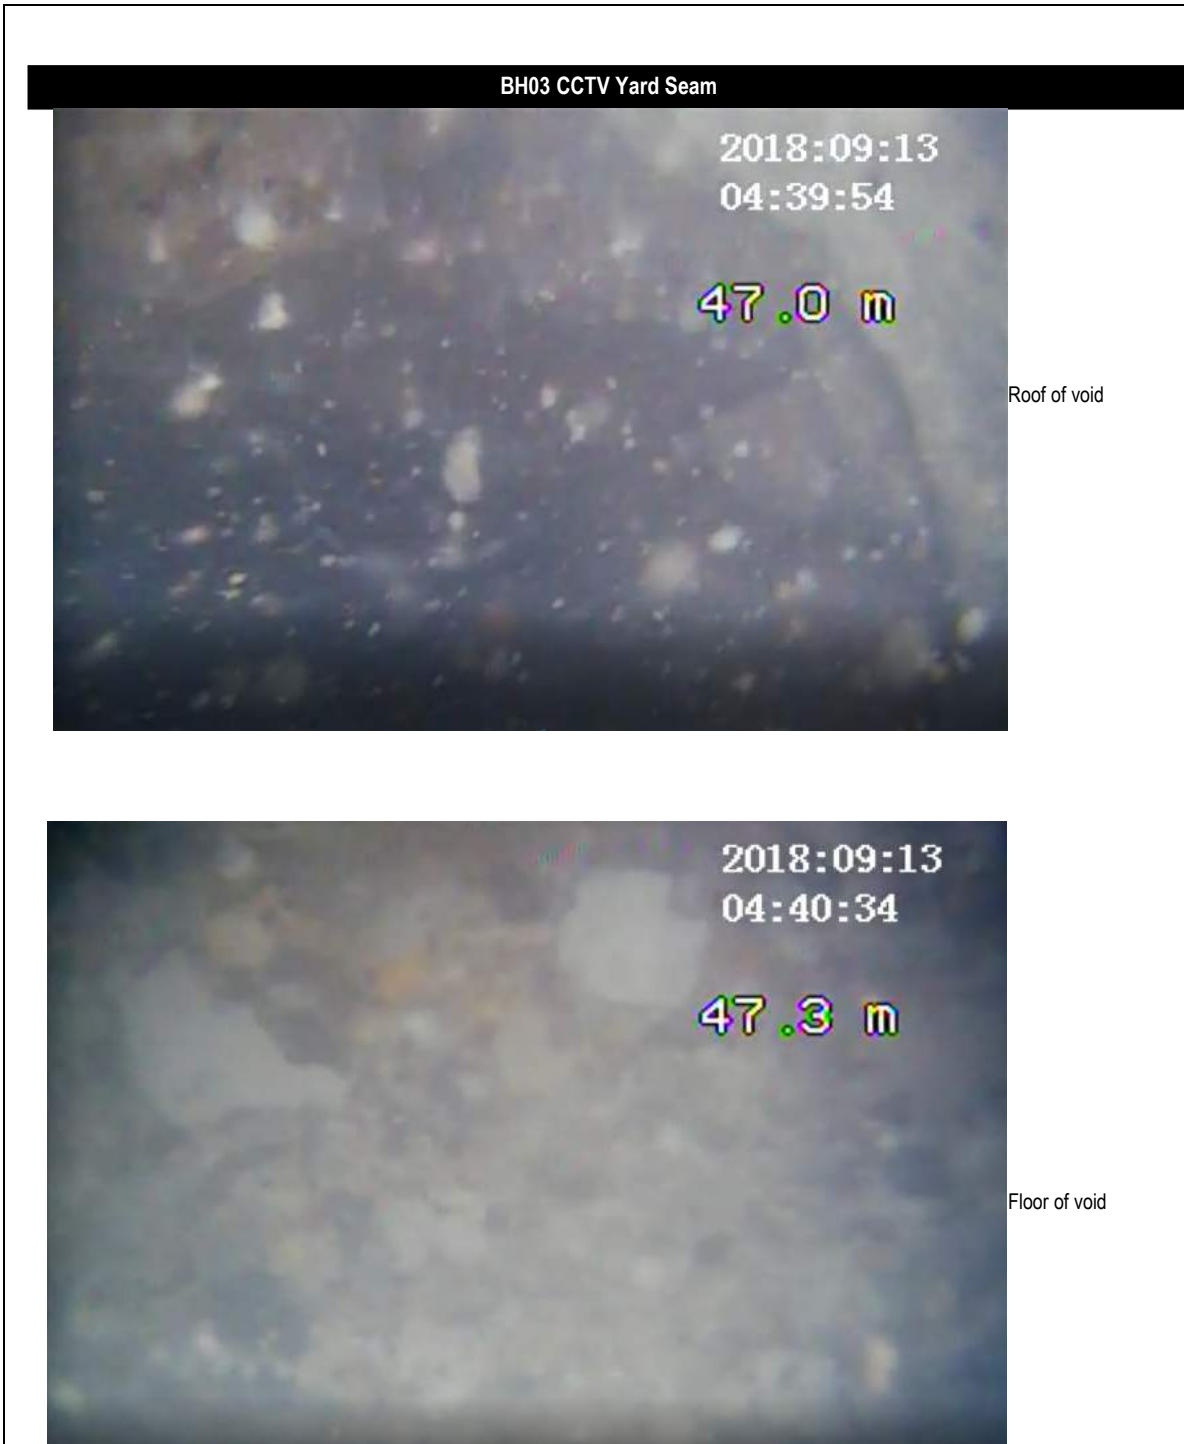
Note depths are approximate only

drawn	<b>SJB</b>		client:	<b>CRESCENT NEWCASTLE PTY LTD</b>	
approved	<b>JD</b>		project:	<b>PROPOSED RESIDENTIAL DEVELOPMENT</b>	
date	<b>2/11/2018</b>			<b>11-17 MOSBRI CRESCENT THE HILL</b>	
scale	<b>N/A</b>		title:	<b>CCTV SNAPSHOTS BH03 YARD SEAM</b>	
original size	<b>A4</b>		project no:	<b>754-NTLGE220504</b>	figure no:

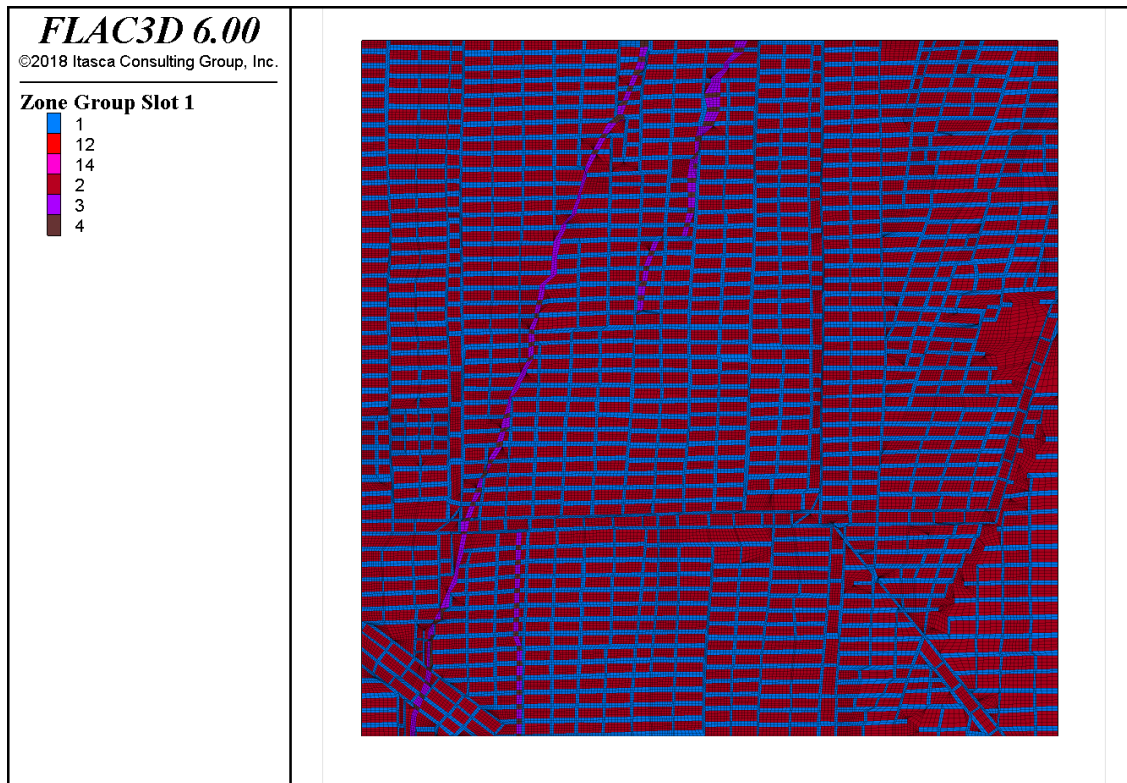
A slight fold in the linen map is observable on the RT566 Sheet 8 images, which decreased the apparent width of the pillars by an estimated 2m. As such, the pillar layout was completed with two parts, the zone above and below the fold on the linen map.

Figure 1: Mesh at Borehole Seam level

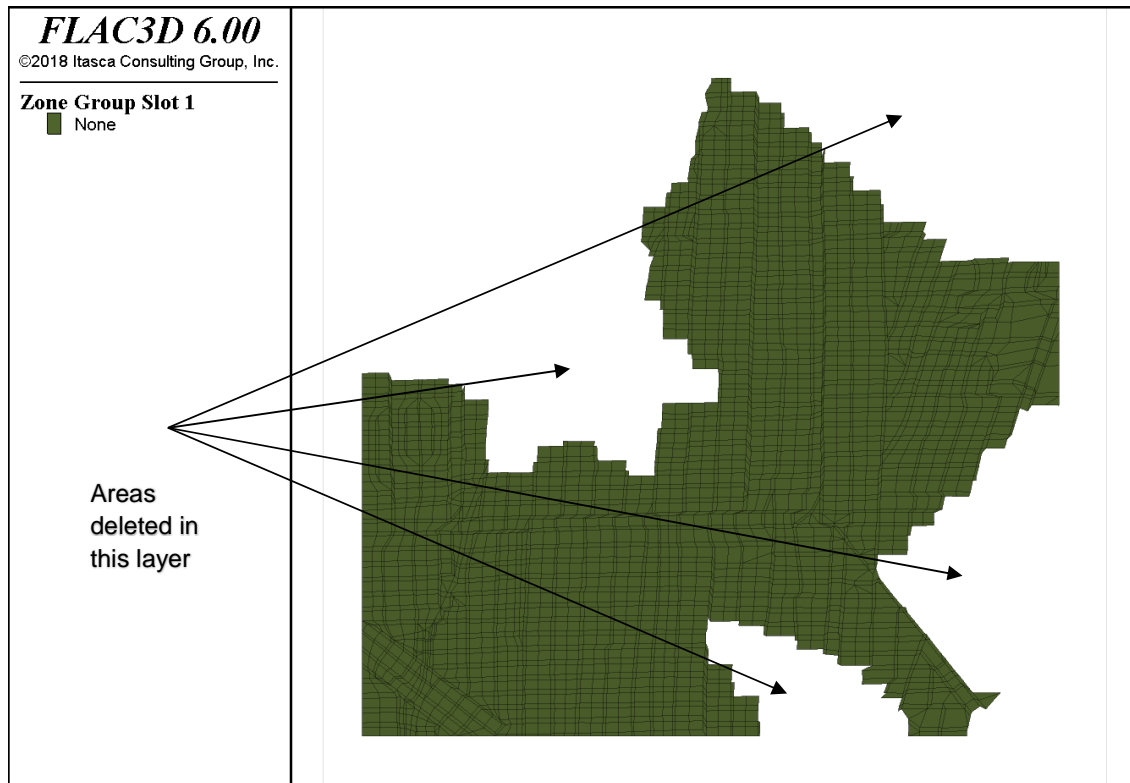
Figure 2: Example of mesh with cut outs for 40m to 45m

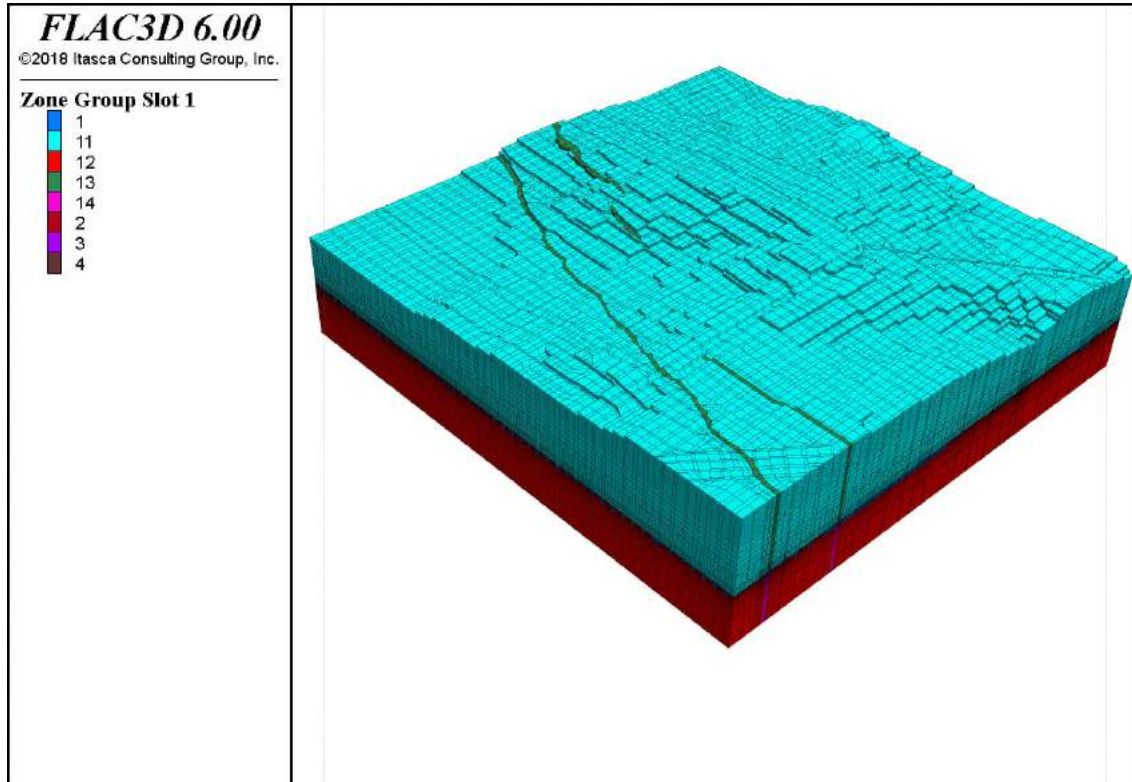
Figure 3: Complete model

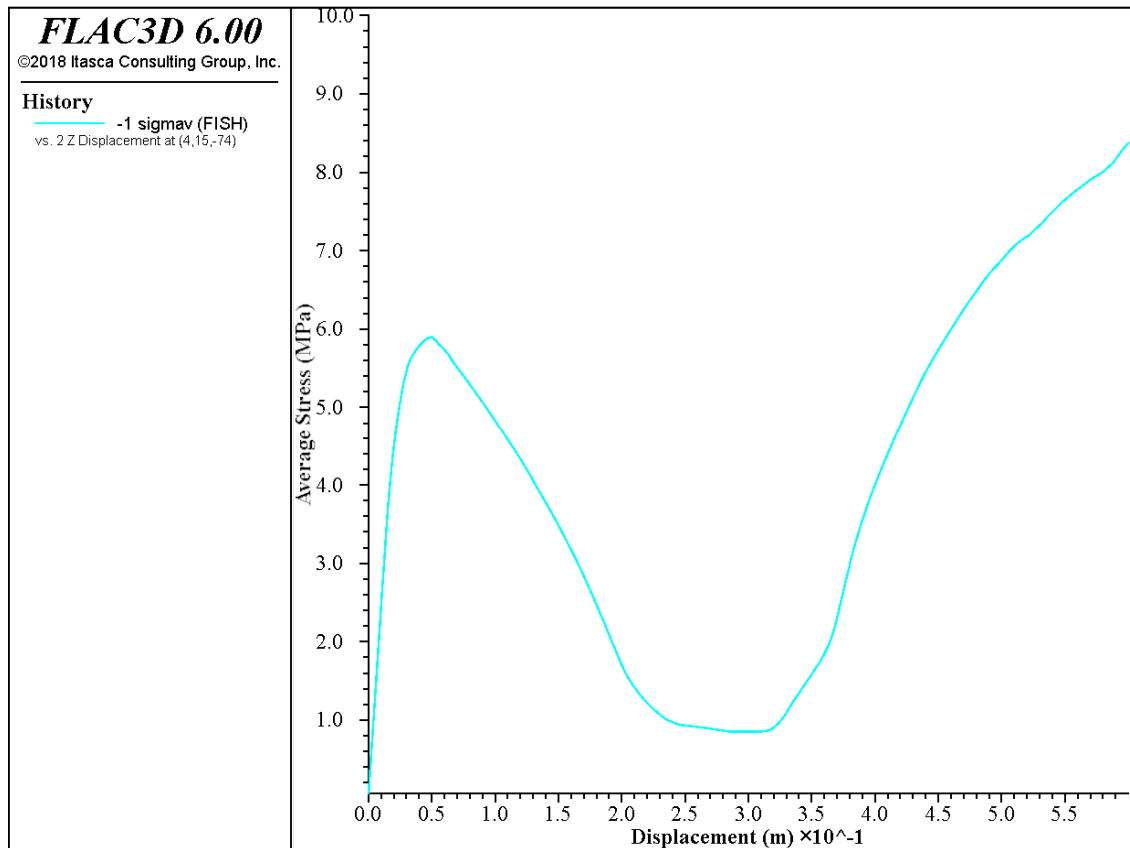
Figure 4: Original pillar calibration for the 10.5m coal pillars assuming a 6.5m height

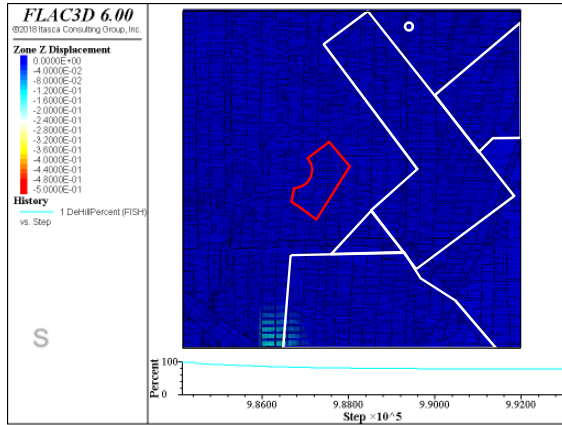
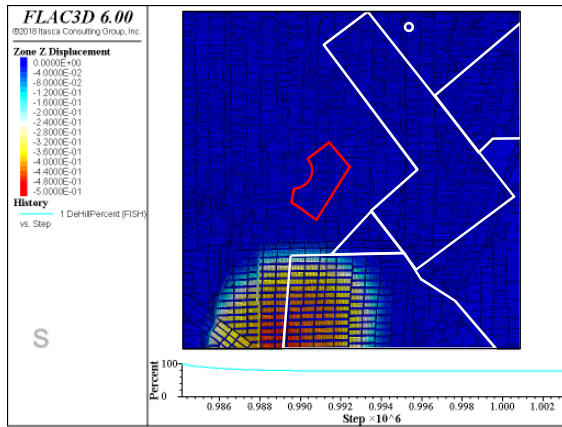
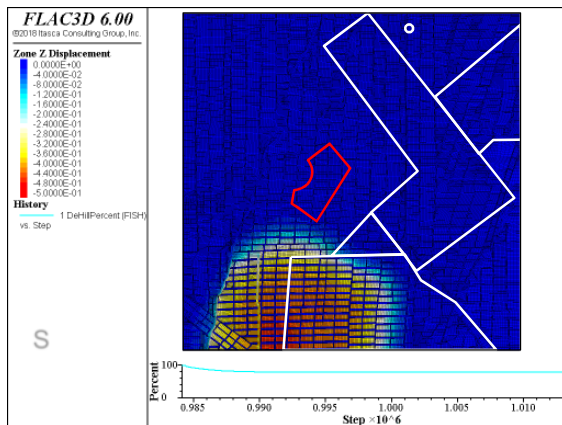
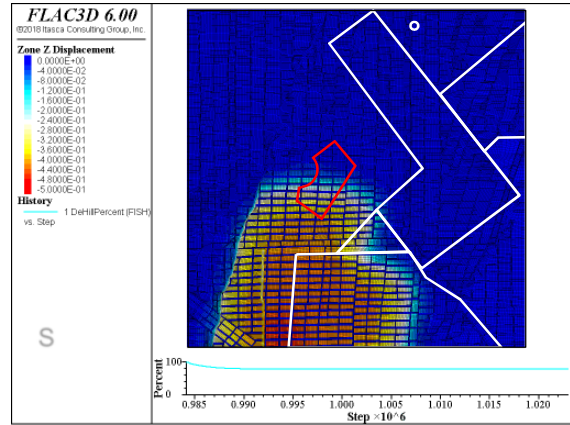
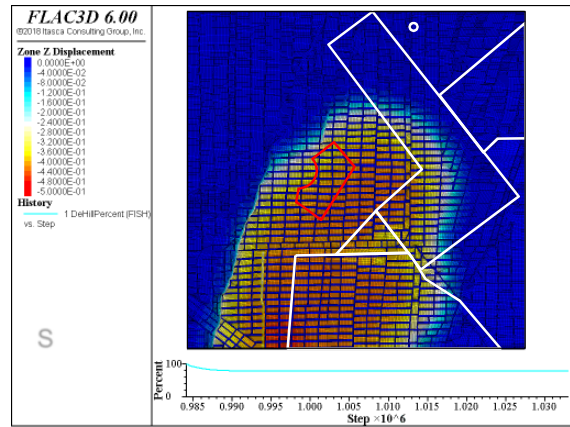
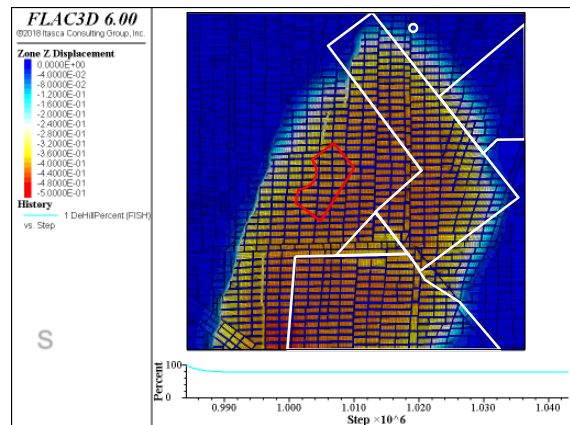
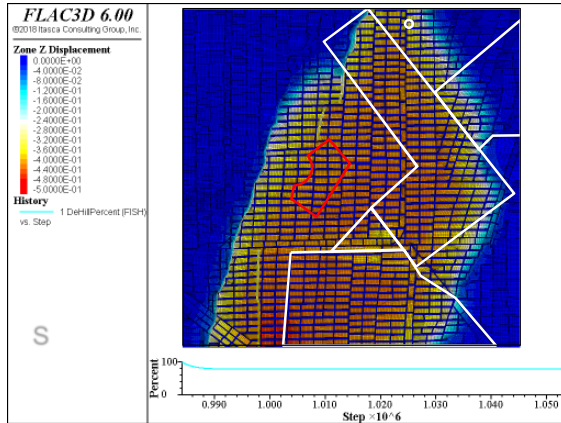
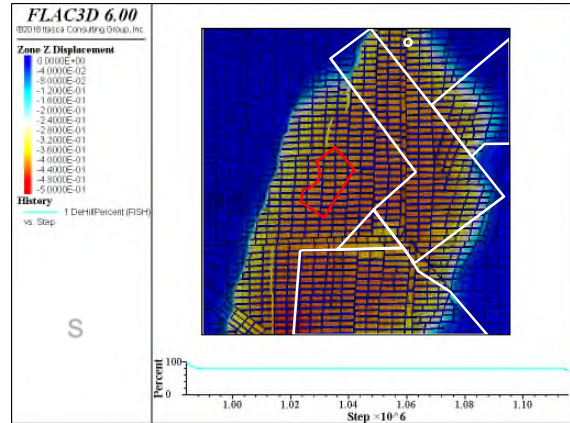
Initially the model was set up with similar properties for all coal pillars. To observe the path of the modelled creep event (pillar failure), a small zone of pillars was weakened at the edge of the model within the Creep 1 area. Screen images were taken regular intervals within solving phase following the path of the modelled creep event. These images are shown in Figures 6 to Figure 13 (refer to Figure 5 for labels of each area).

This resulted in a creep pattern that is inconsistent with the pattern of the actual historical creep events. As can be seen in the above, once the creep event is initiated, the creep event would be expected to progress through the whole area if the mining height was equal. However, it is known the heading south of The Site stopped the progression of historical Creep 1. A variation in mined heights or other variable must be considered to account for this discrepancy between the initially modelled creep and the known progression of the actual historical creep events.

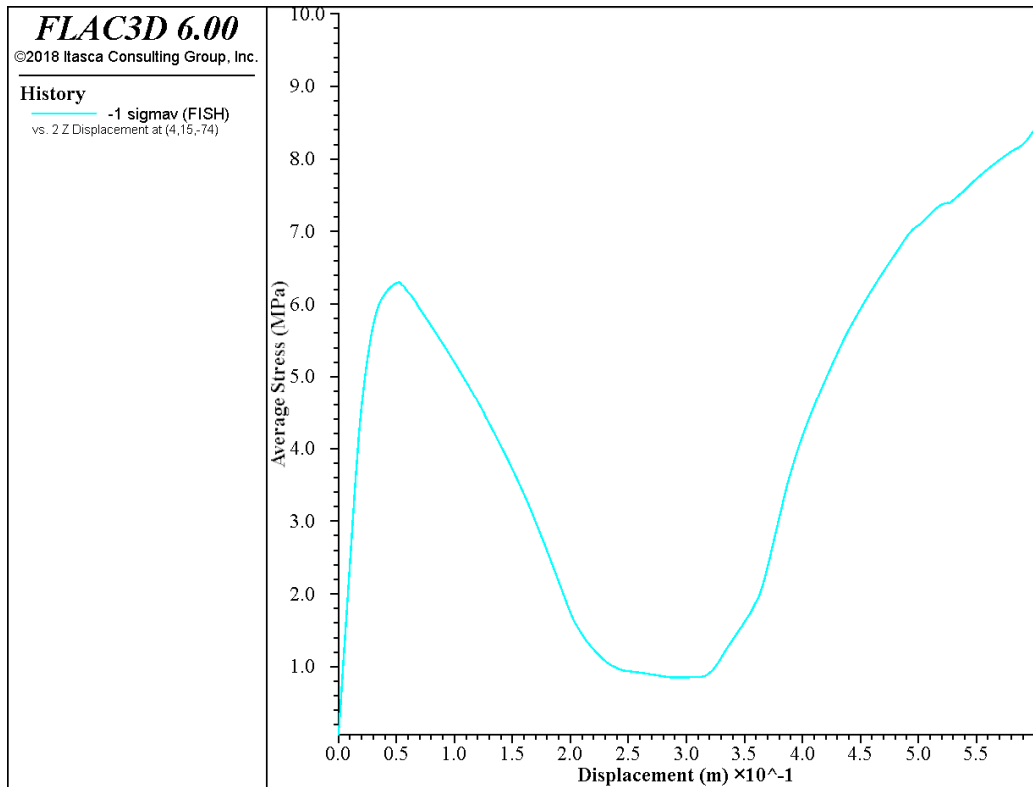
Even though the thickness of the coal seam at The Site was only 6m, the coal pillars appear to have not been crushed by past creep events (Coffey Report 754-NTLGE220504-AH.Rev2 dated 17 December 2018). As such, the strength of the coal around the site must be higher than the surrounding area. To more closely resemble the historical Creep events, the coal strength around The Site was increased in stages in order to simulate the historical creep events in the remodel. This was simulated by increasing  $c'$  to 1.03MPa (similar to 6.0m high coal pillars), then to 1.1MPa, and finally 1.2MPa (similar to 5.1m high coal pillars.) Coal strength recalibration is shown in Figures 14 and 15. Figure 16 shows the area to recalibrated coal strengths are modelled.

Figure 14: Recalibration curve with c' assumed to be 1.03MPa

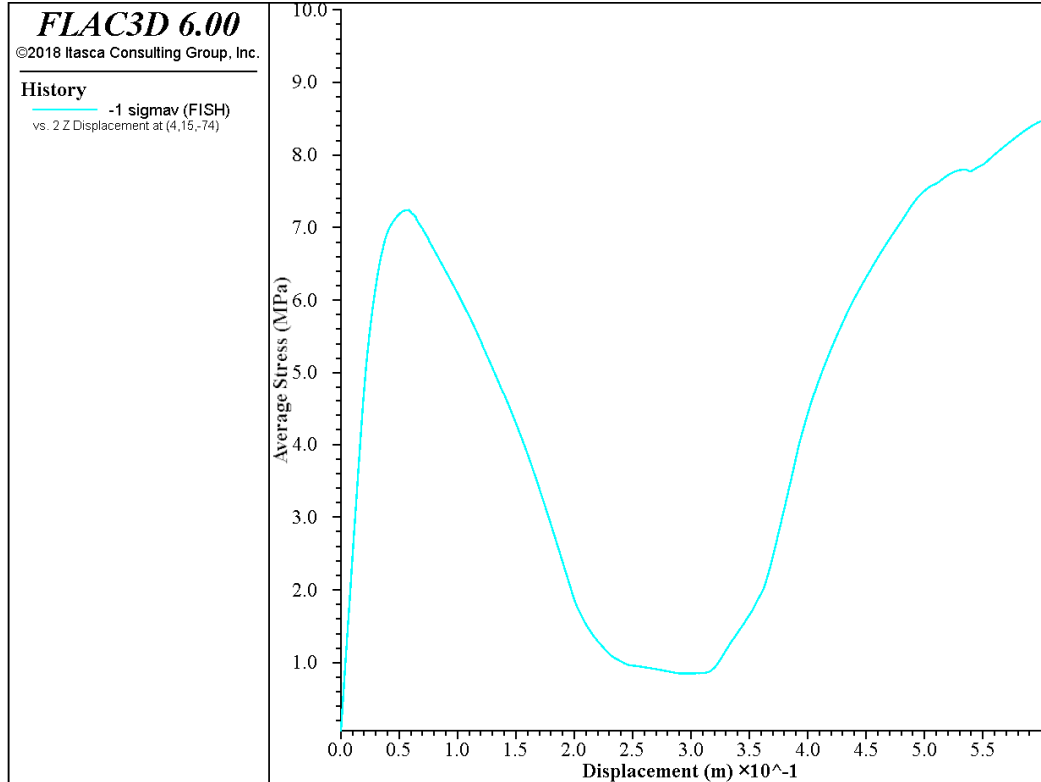
Figure 15: Recalibration curve with c' assumed to be 1.2MPa

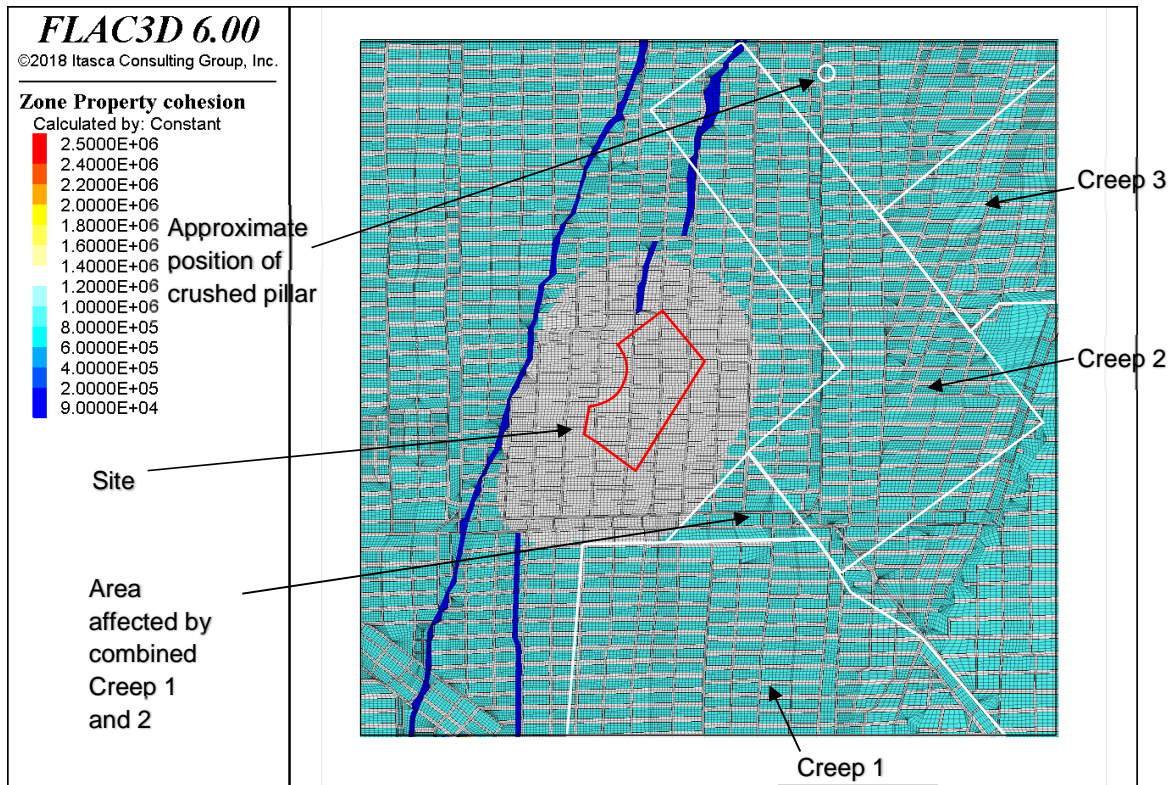
Figure 16: Area with higher cohesion in each reiteration

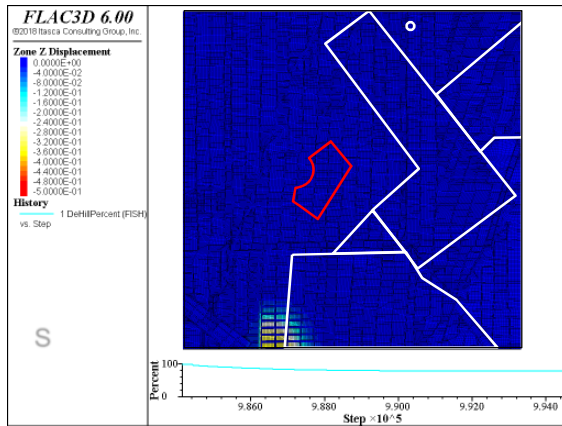
Figures 17 to 25 shows the sequence of image stills showing the path of the modelled creep assuming coal strength  $c'=1.03\text{MPa}$  (note the  $c'$  of the upper 2m roof collapse shale and silty coal is assumed to be 1.5 times higher).

Figure 17: Screen shot one of modelled creep  $c' = 1.03\text{MPa}$

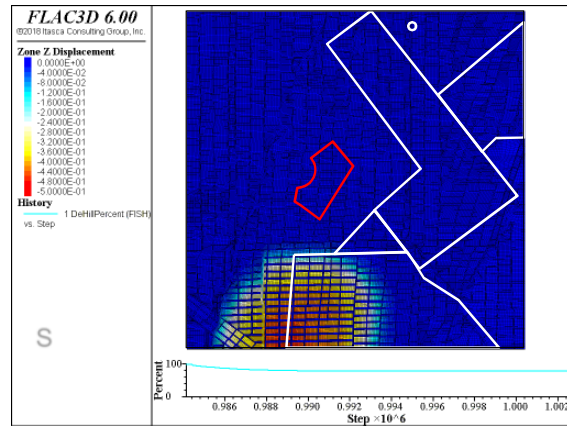
Figure 18: Screen shot two of modelled creep  $c' = 1.03\text{MPa}$
